## Historic buildings Chalk and clay cob

This leaflet describes the character of mass cob, identifies some of the problems associated with it, and methods of repair.

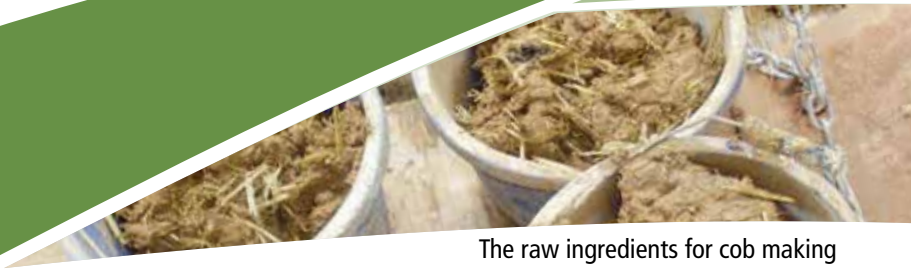
The raw ingredients for cob making

Cob is a lump material made of clay, marl and chalk mixed with gravel and straw as a bonding agent.

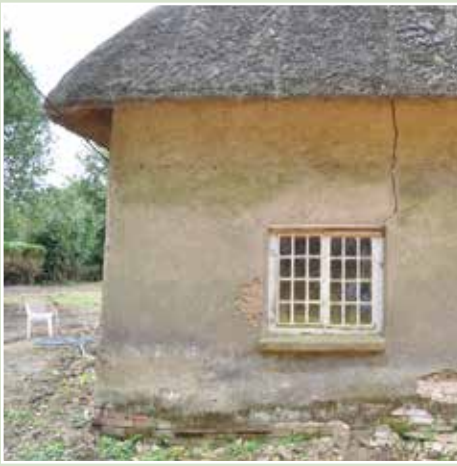
▶ Small building with typical problems affecting cob - the walls are cracked as a result of movement and constant dripping of water which has worn away the face of the render and the base of the wall. The building has been reinforced with a buttress and new render has been applied to part of the wall

Detailing can be a problem for cob. If a roof is defective or has changed in later years, for example from thatch to tile with a reduced eaves overhang, constant dripping of water can eventually wear away the face or base of the wall.

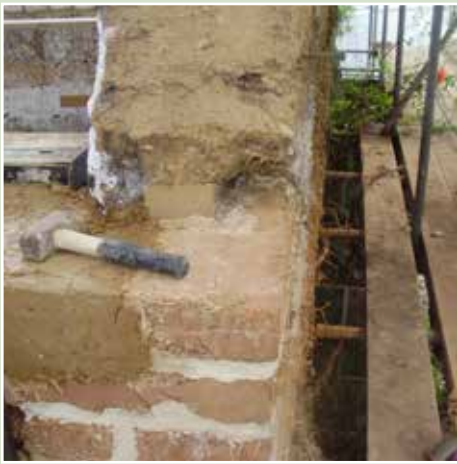
Cob repairs in progress

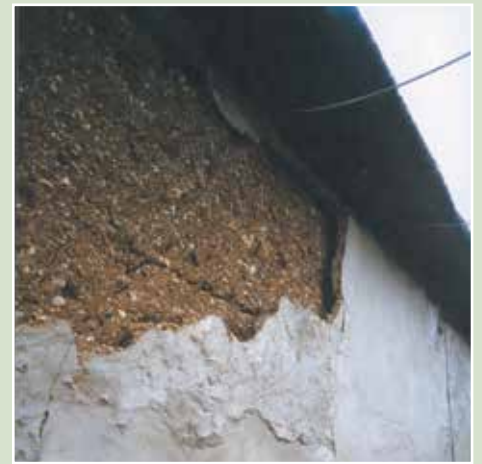
Moisture trapped behind cement render

Treatments such as the use of cement render, can cause severe problems. The rigid render inevitably cracks, allowing moisture to become trapped behind, eroding the cob and in winter freezing and bursting the render off the wall. Furthermore, a constant accumulation of water can lead to an instant and dramatic slump, where entire sections of wall can fail.

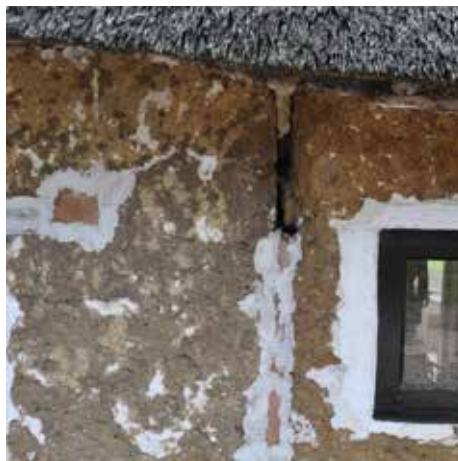
◀ Cob wall which is in poor state of repair. The capping is inadequate allowing water to enter, surface render has failed and the foundations are weak
